ENVIRONMENTAL MEMORANDUM

Red Chris Development Company Ltd.
200–580 Hornby Street, Vancouver, BC V6C 3B6

Date: December Jan 26, 2016

Re: Red Chris Monitoring Committee Environmental Report Jan 12 – Jan 26, 2016

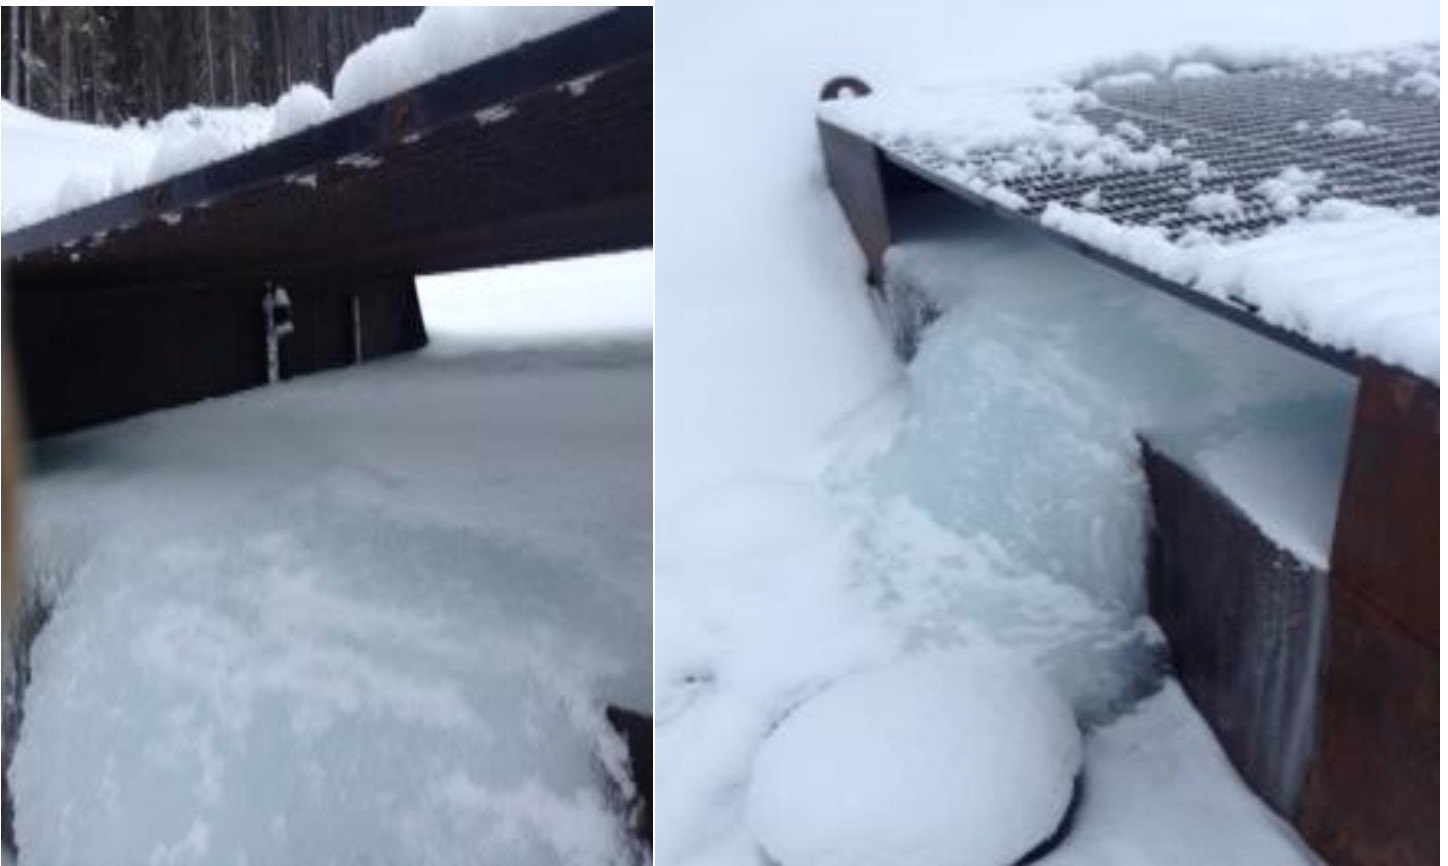
- The North Reclaim Dam Discharge (NRDD) Weir is completely full of ice, thawing of ice can cause implications in the spring.

Figures 1 & 2: Jan 11 – The NRDD weir has filled with ice from non-contact seepages.

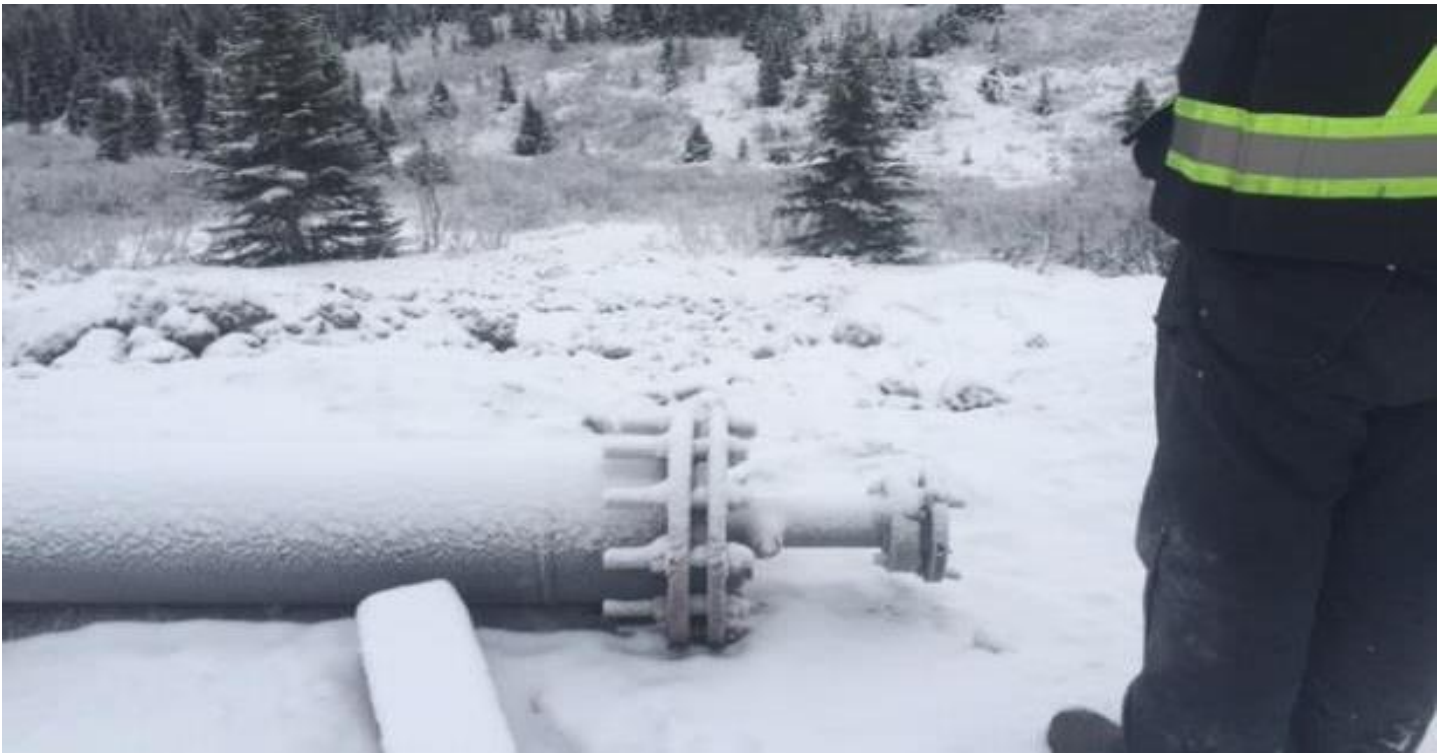
Figure 3: Jan 11 – Large chunks of ice have been cleaned up around the pit sump (water sample site W75) and there is no further drainage into Camp Creek.

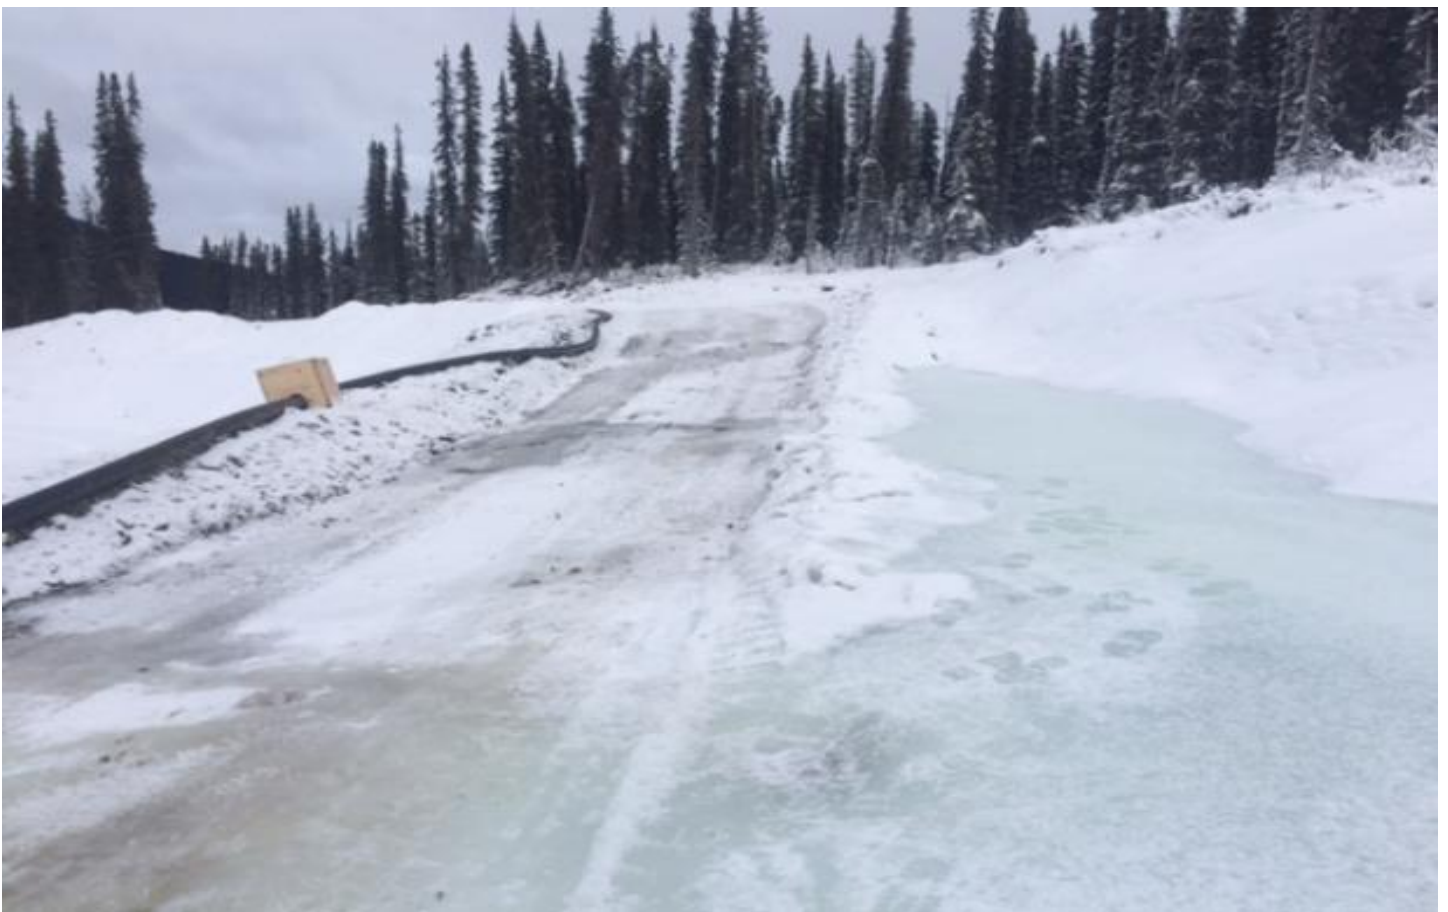
Figure 4: Jan 11 – Above the North Reclaim Dam spillway there's been water flowing through the road and down into the catchment ditch and the spillway itself.

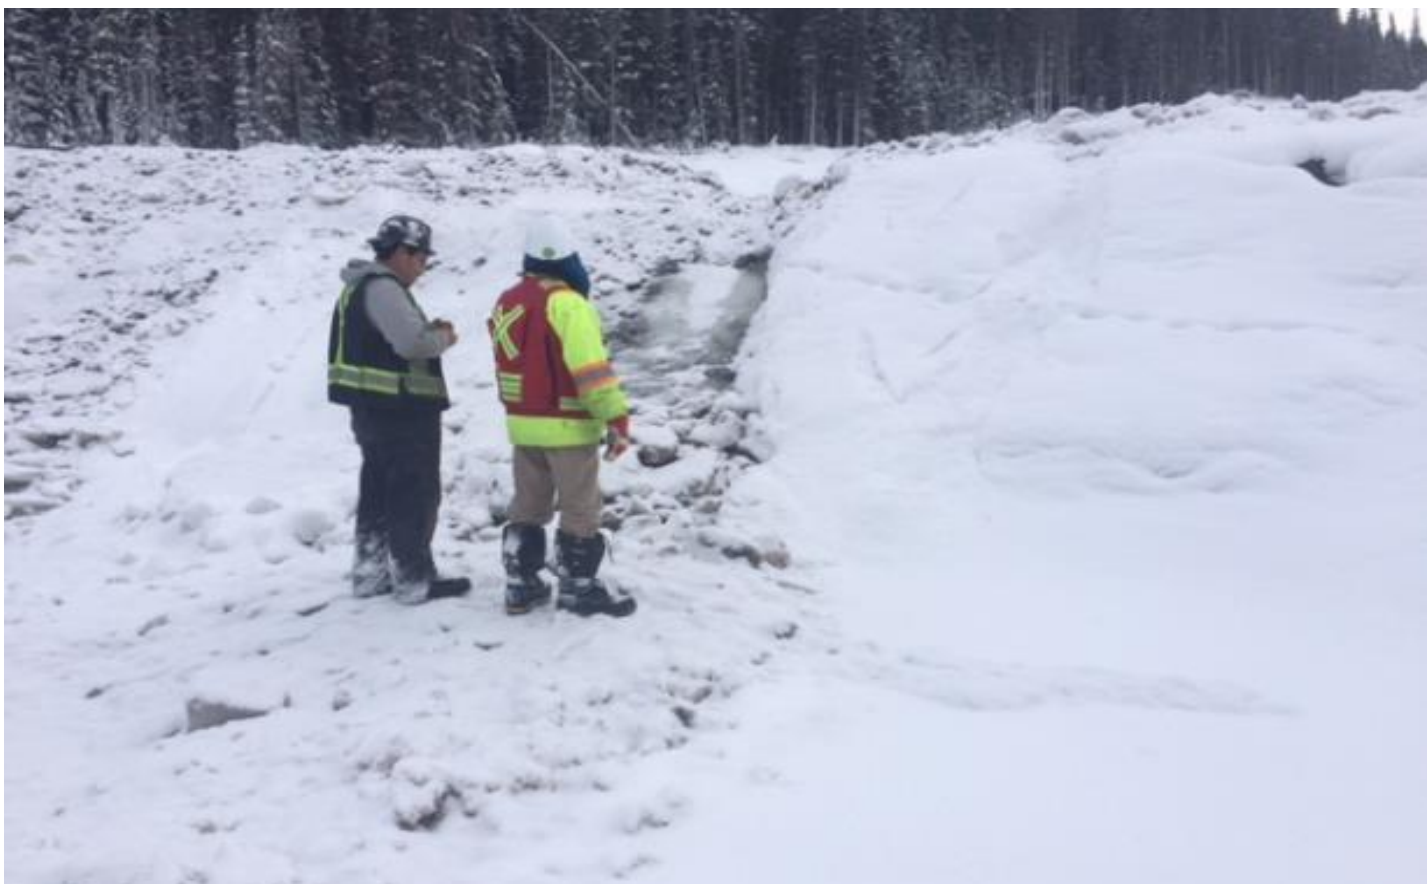
Figure 5: Jan 11 – A view from below the road pictured above.

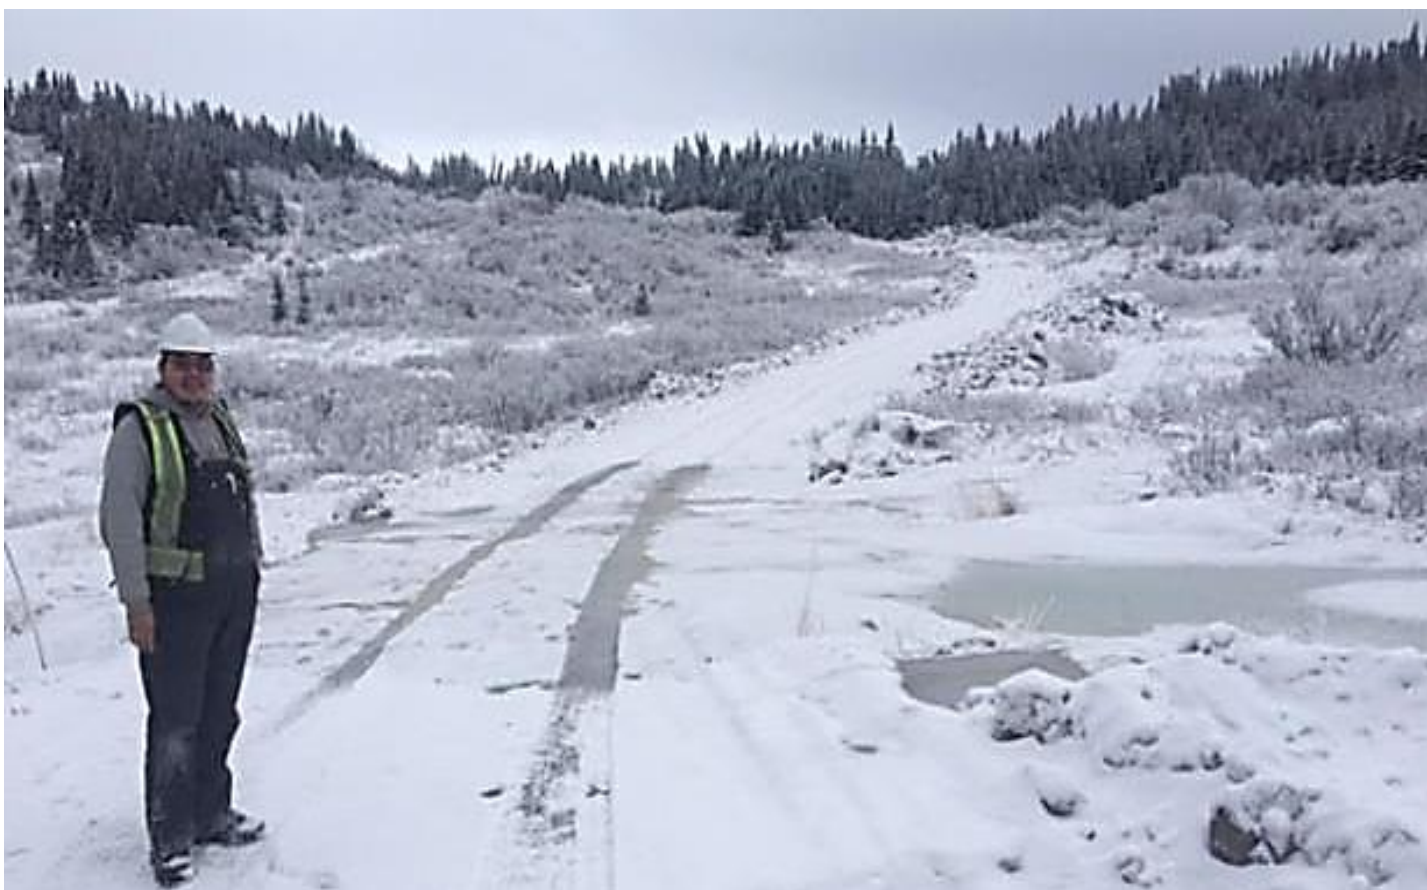
- The culvert installed at the bottom of the repeater station is ice jammed and overflowing on the surface. A new structure will need to be sought to provide a safe, sturdy low maintenance and environmentally sound crossing, with a waterway opening large enough to pass peak flows and ice jams. Choosing an area to cross is difficult with the current conditions. The crossing has been put on hold for the time being until a proper solution can be reached.

Figure 6: Jan 11 – The crossing of Camp Creek to the new pit repeater station location.

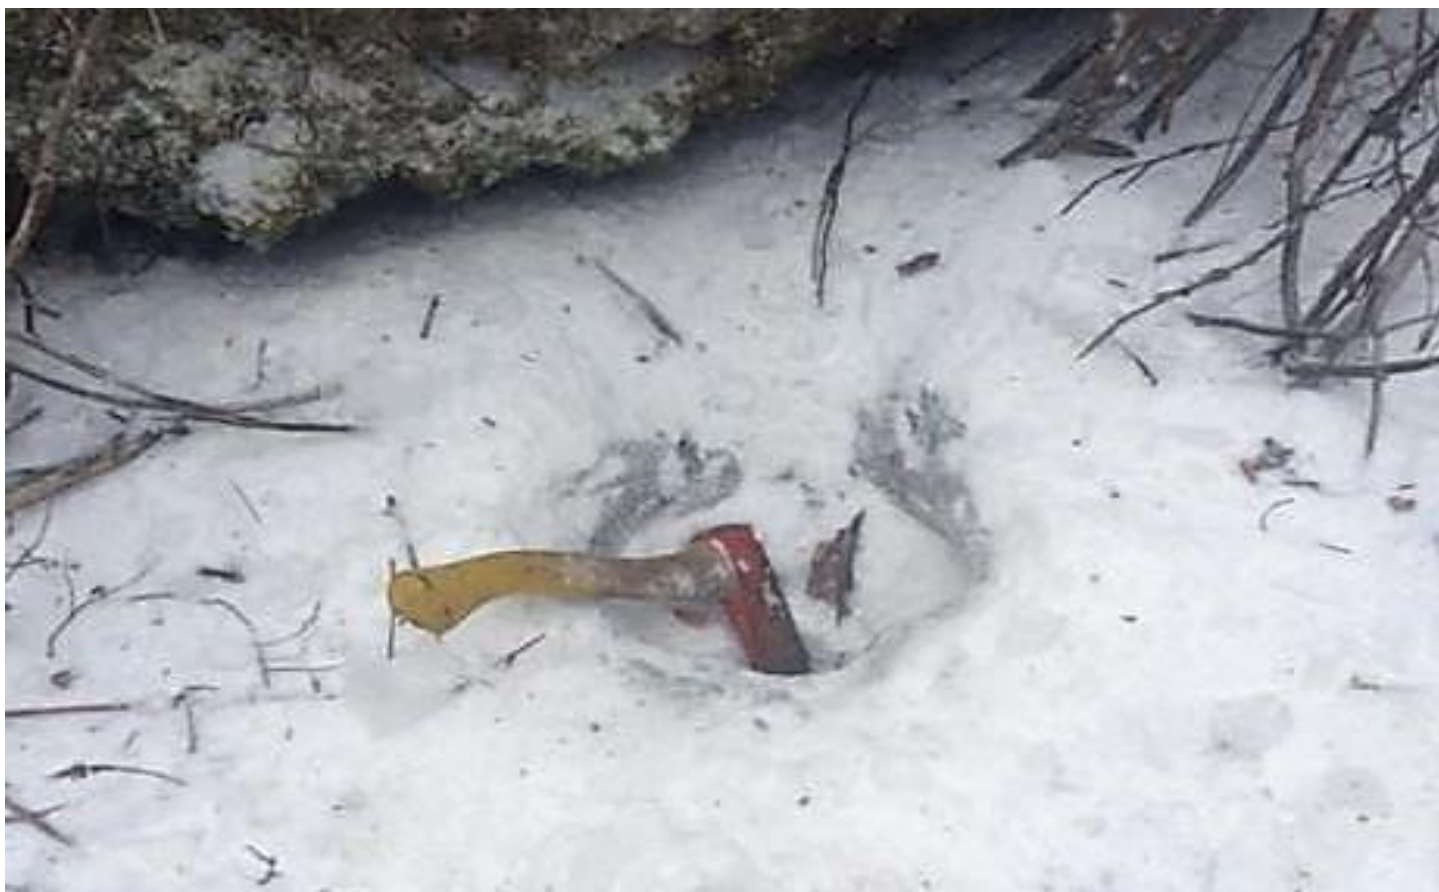
Figure 7: Jan 11 – Waste sample site TC2(2nd site on Trail Creek) still has no sign of water.

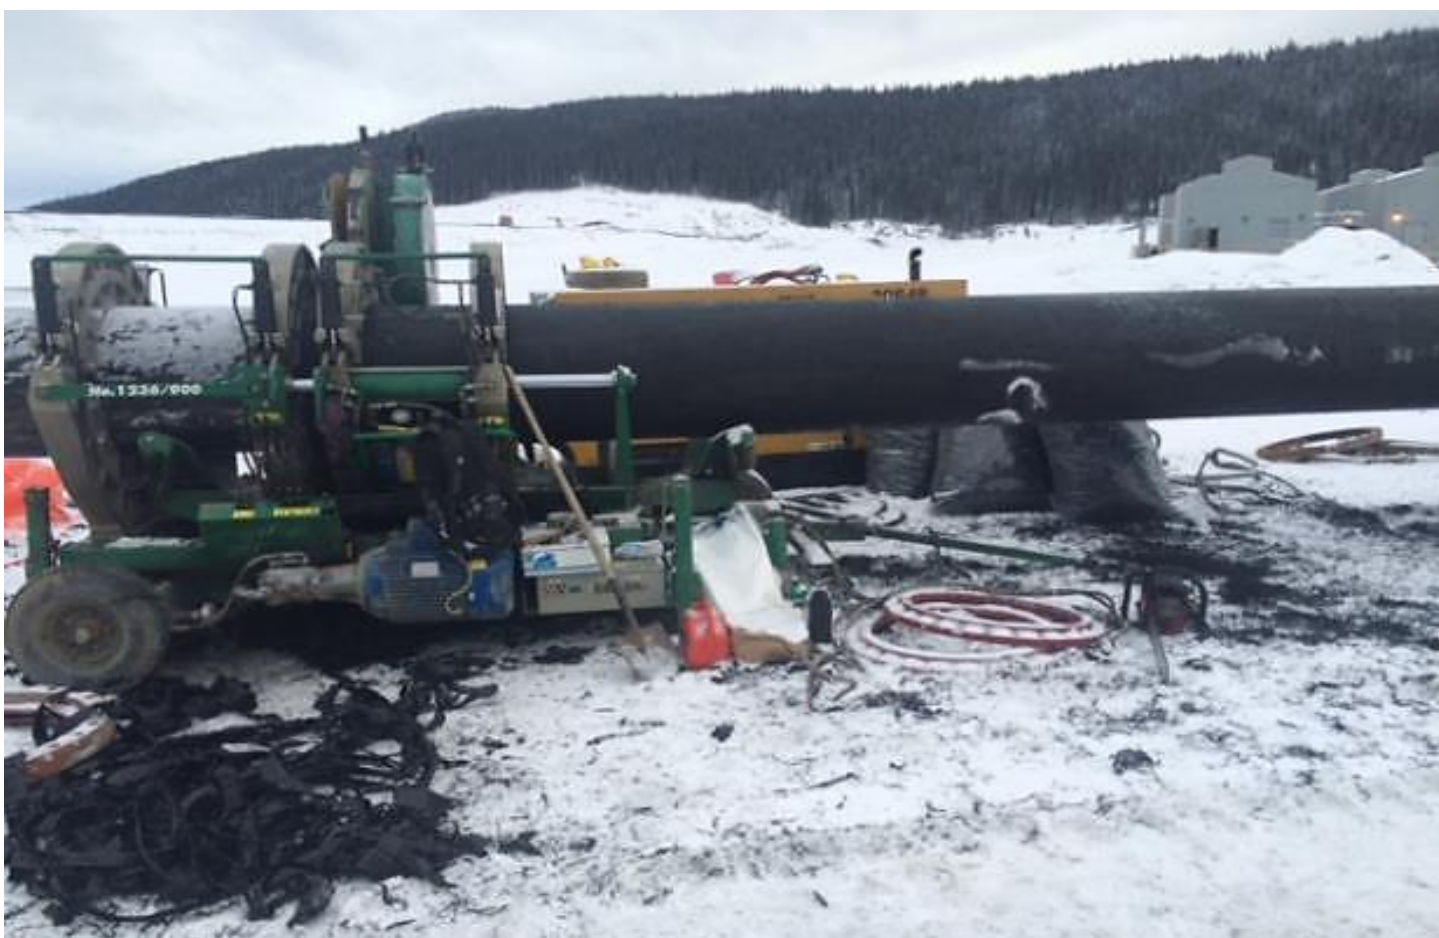
Figure 8: Jan 11 – There is a plan being developed to recycle HDPE shavings from fusing pipes.

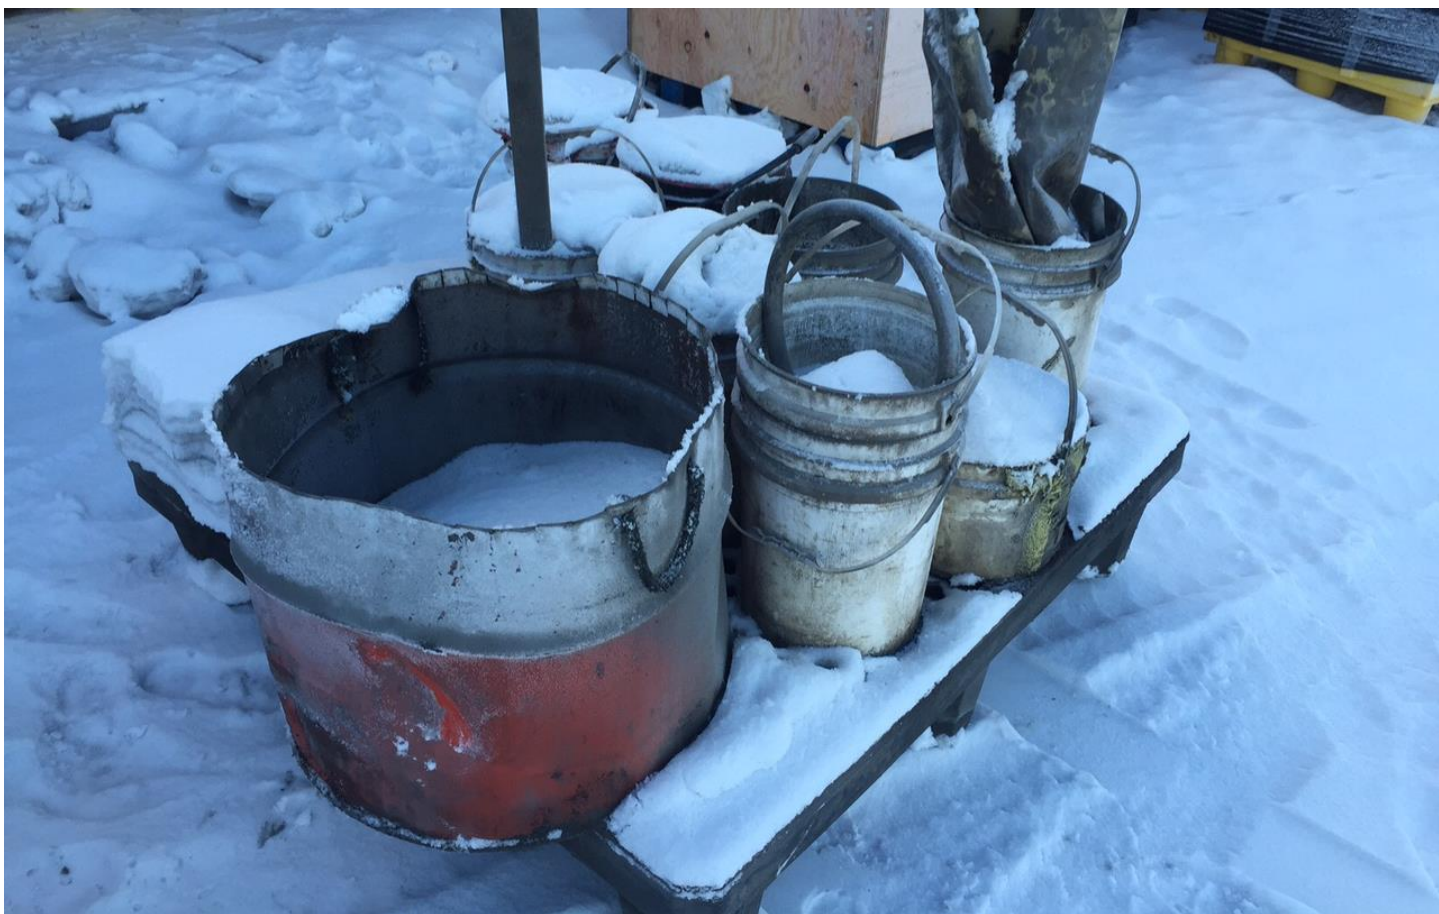
Figure 9: Jan 14 – Proper waste disposal and organization continues to be a challenge.

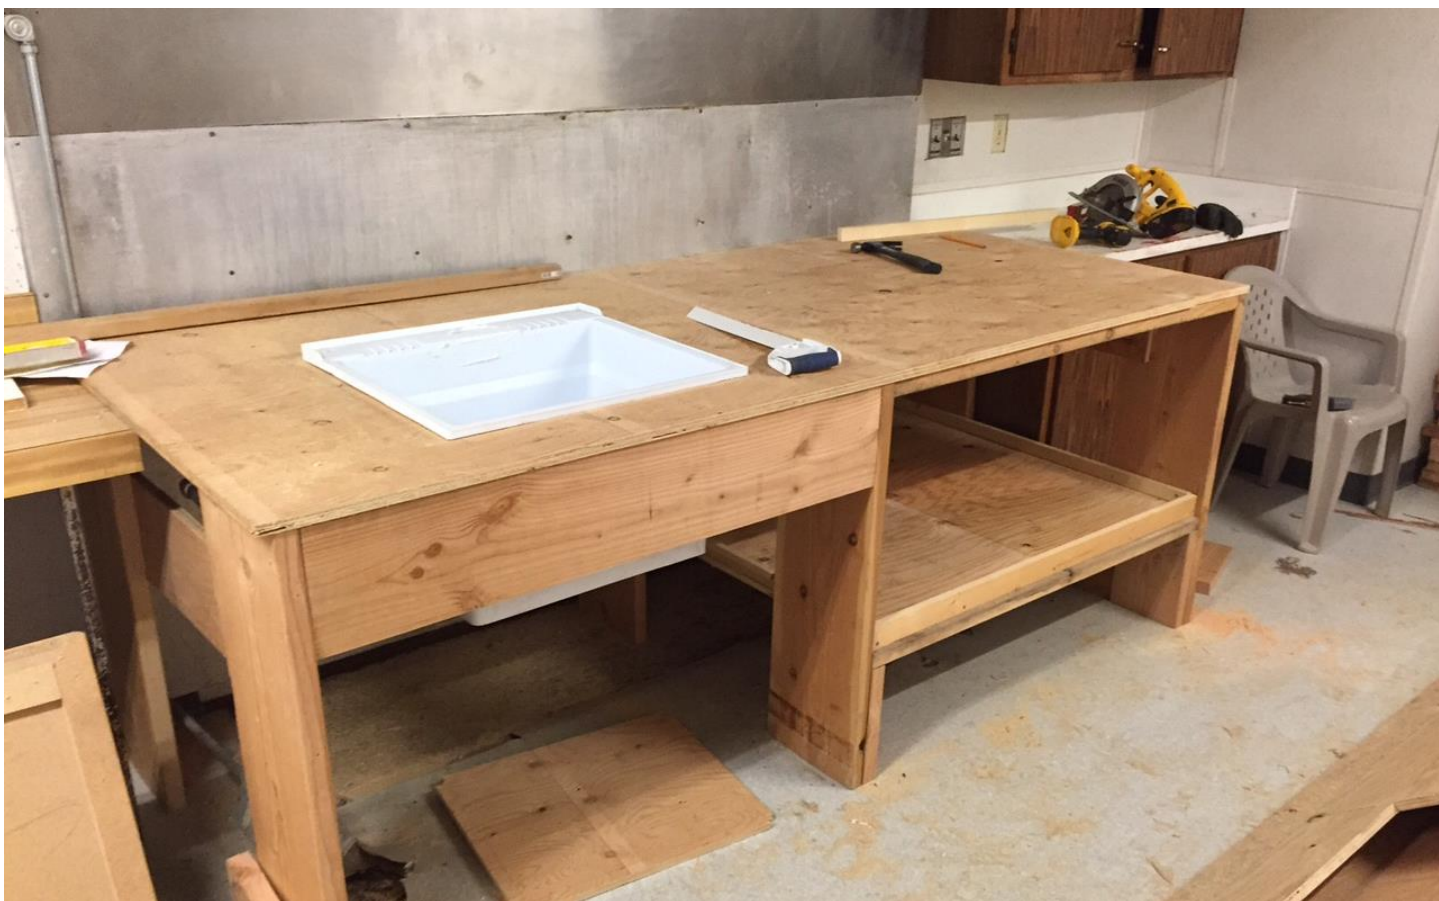
Figure 10: Jan 15 – Building the laboratory for preparation of water samples is coming along well.

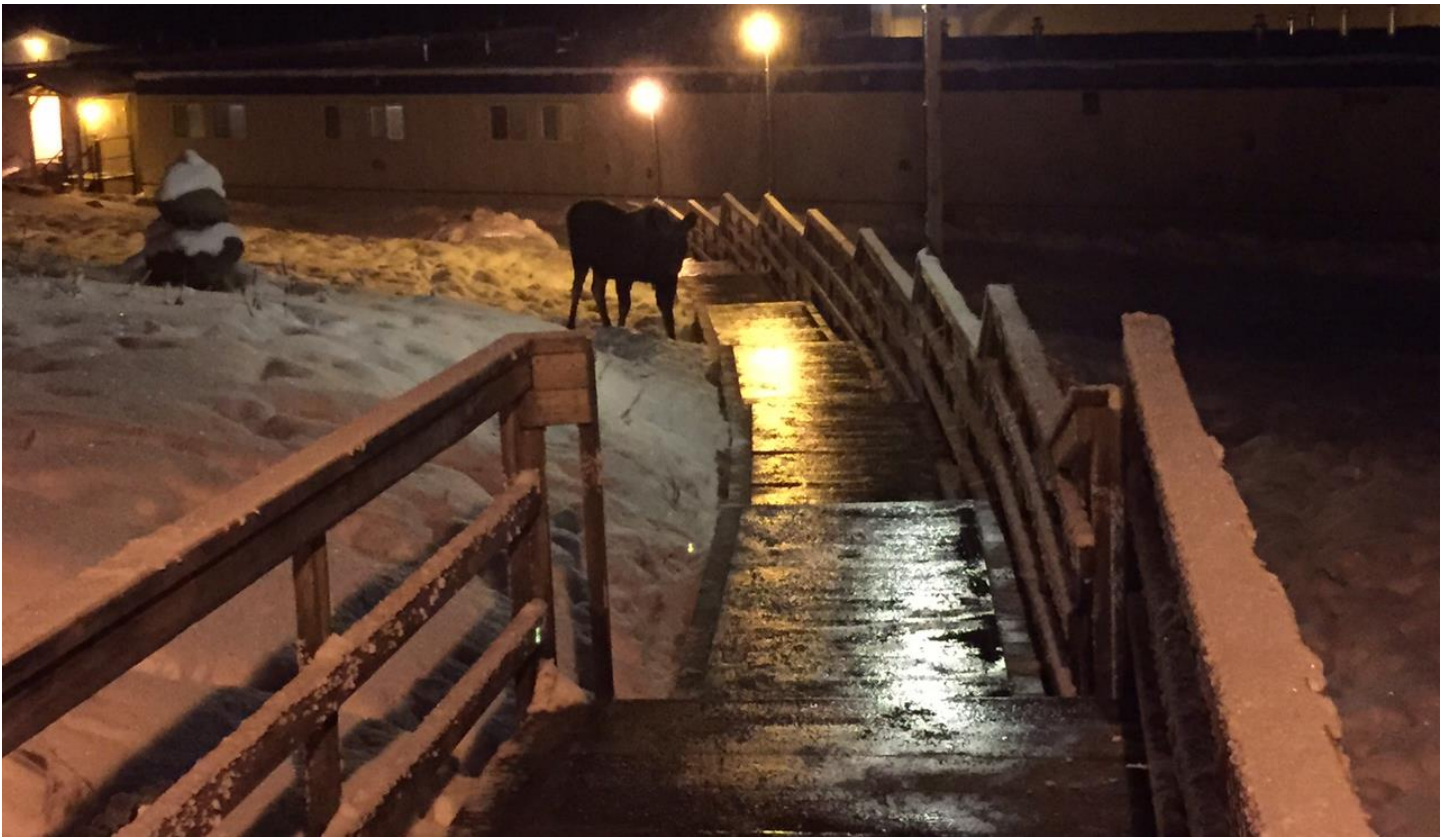
- Cow and calf continue to be spotted near the bunk houses grazing vegetation and licking the salt off of the walkway.

Figure11: Jan 18 – The maintenance staff had started using salt again to melt the snow on the back walkway to the parking lot. This had attracted the moose once again.

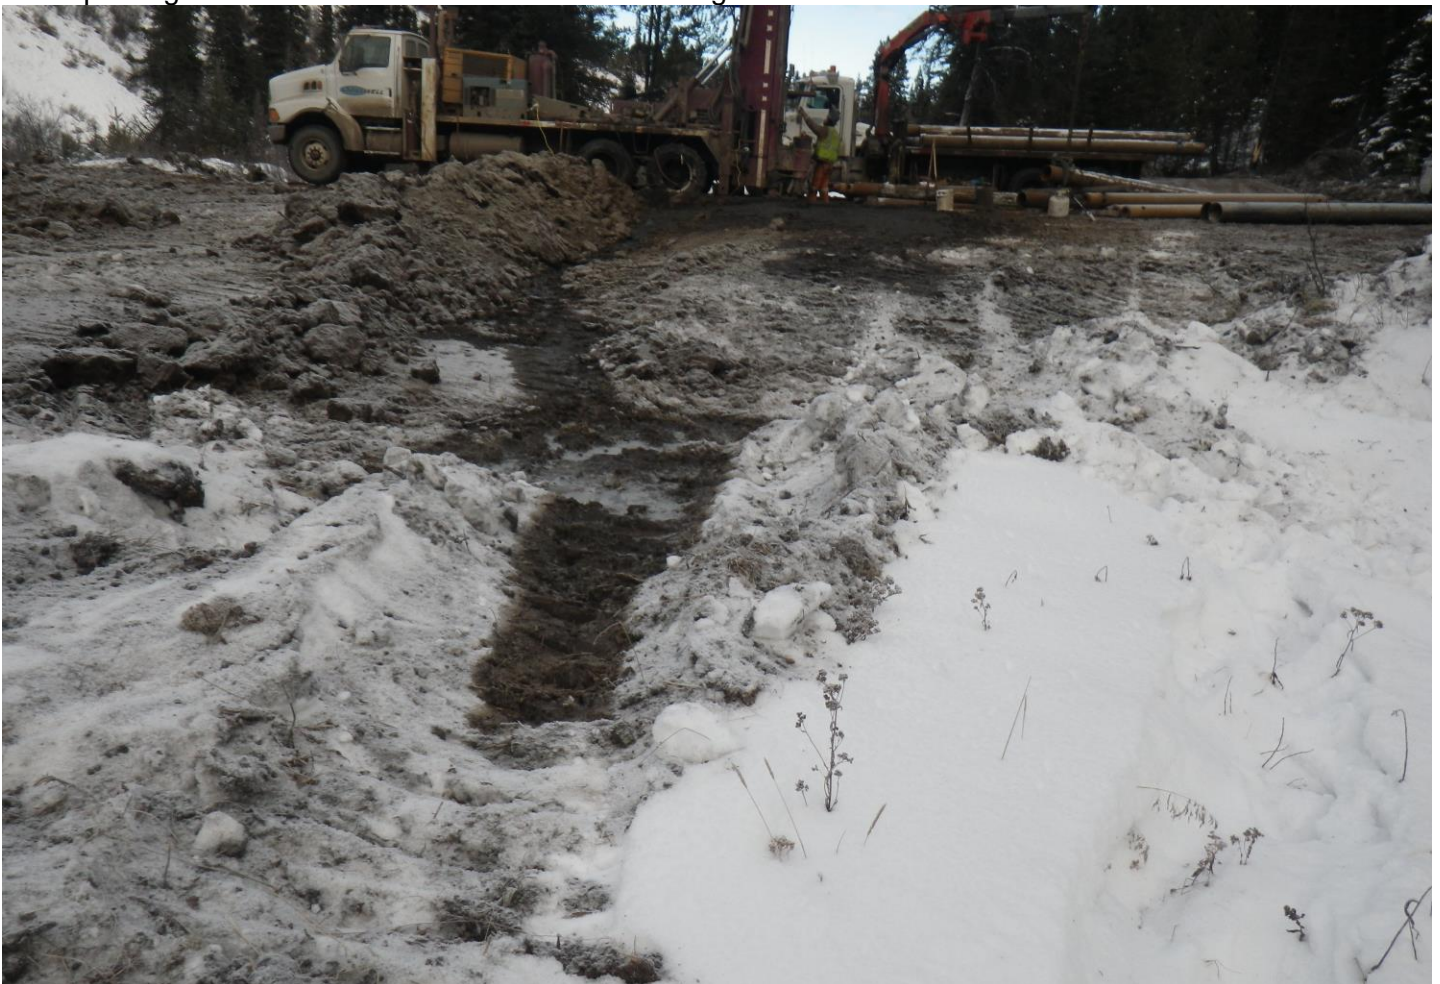
- Drilling in the South TIA had brought up some water drainage issues that are being worked on to prevent cuttings from the drill reaching Trail Creek. A sump is in place to help water to settle out with the final spillway going through a series of sediment fencing before it can reach the creek. The water soaked into the ground before it even made it to the sump.

Figure 12: Jan 20-The water and cuttings didn't even make it to the sump before the water soaked into the ground.

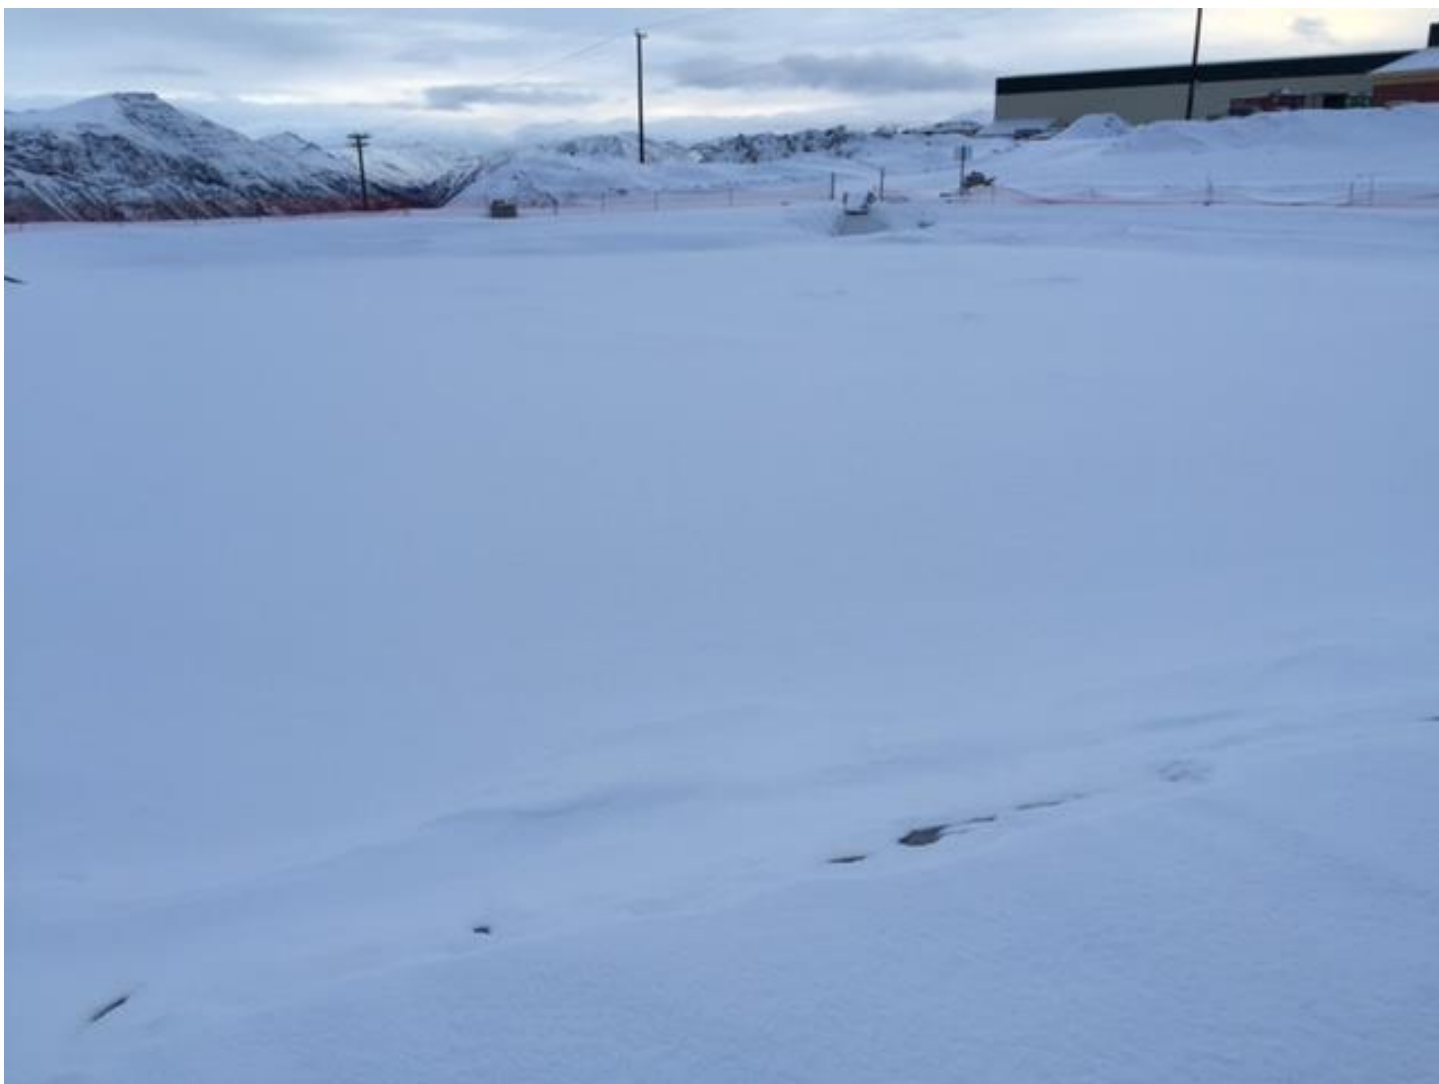
- Lagoon blowers have been operating without interruption but it is unlikely that the lagoons are getting any aeration as both lagoons are completely frozen over. The decision has been made to shut them down until spring. Monitoring will be continued per usual and will be documented. It does not look like there will be any need to discharge at all this winter.

Figure 13: Jan 22 - Lagoon 1 – There is not much hope in aerating a completely frozen over lagoon.
